2002 Mercedes Benz C 32 AMG (203.065) V6-3.2L SC (112.961)

[Notes](#)**Lighting - Front Turn Signals Inoperative**

Order No.: P-B-82.10/195c

**SUBJECT:**Model 203, Model Years 2000 and Later  
Front Turn Signal Inoperative

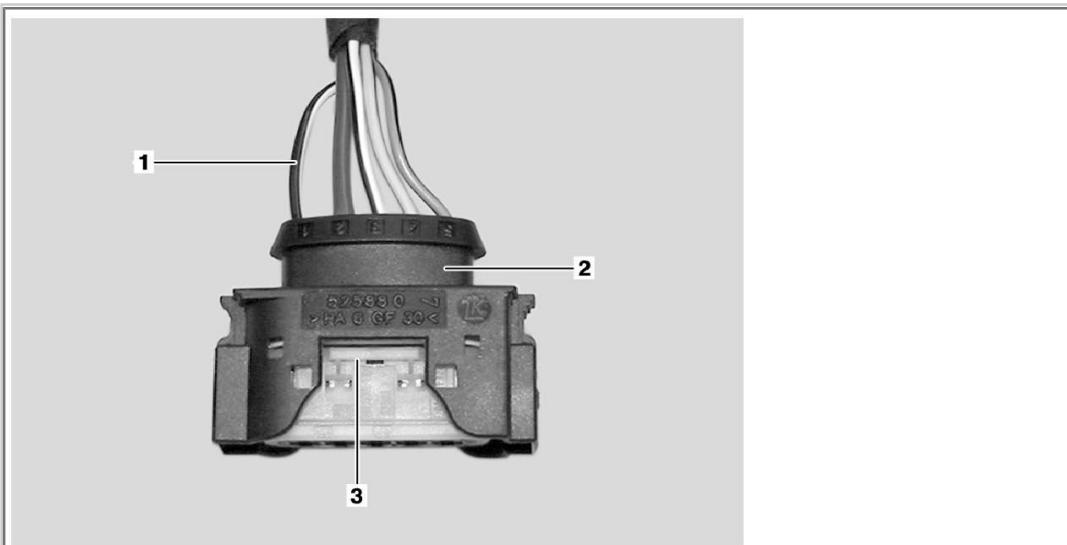
Figure 1  
Plug from headlamp assembly  
1 Turn signal wire located in chamber 1 of existing headlamp housing connector (2)  
2 Headlamp housing connector  
3 Connector locking tab

4. Open pin lock (3, Figure 1) on connector (2, Figure 1) and "un-pin" turn signal wire (1, Figure 1) from connector. Left side, pin 1 is white/black. Right side, pin 1 is green/black. Refer to WIS document no. AR00.19-P-0120-02B, Removing Contacts from Sensor Connector.
5. Plug empty chamber with a rubber plug, refer to parts information section for part number.

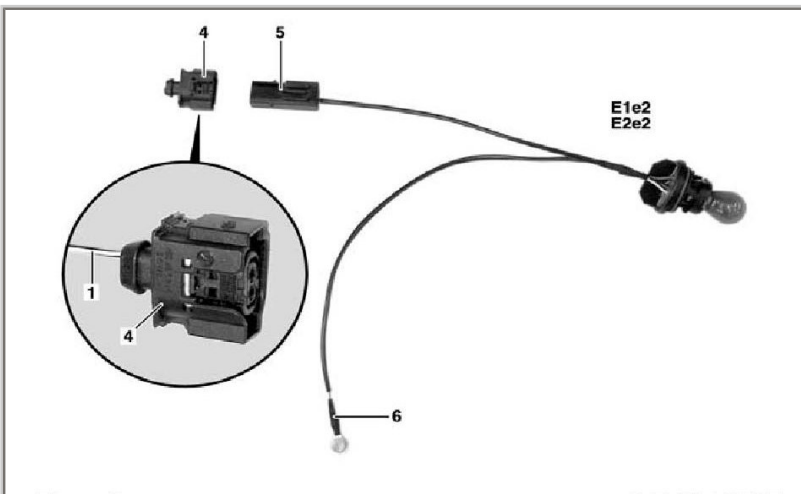
Figure 2  
Turn signal repair set  
1 Turn signal wire from headlamp  
4 Repair set connector  
5 Turn signal bulb socket connector  
6 Turn signal bulb socket ground wire

6. Remove contact housing (4, Figure 2) from connector (5, Figure 2) and insert "un-pinned" turn signal wire removed in step 4 (1, Figure 2) into chamber 2 of contact housing (4, Figure 2) (from repair set). Prior to assembly, check individual gaskets for damage.
7. Reconnect contact housing (4, Figure 2) with connector (5, Figure 2). Housing must audibly click into place.
